SQUAW MOORING PROJECT  
FINAL REPORT  
VOLUME 1

**SQUAW MOORING PROJECT  
FINAL REPORT  
VOLUME 1**

**FPO-1-78(18)  
SEPTEMBER 1978**

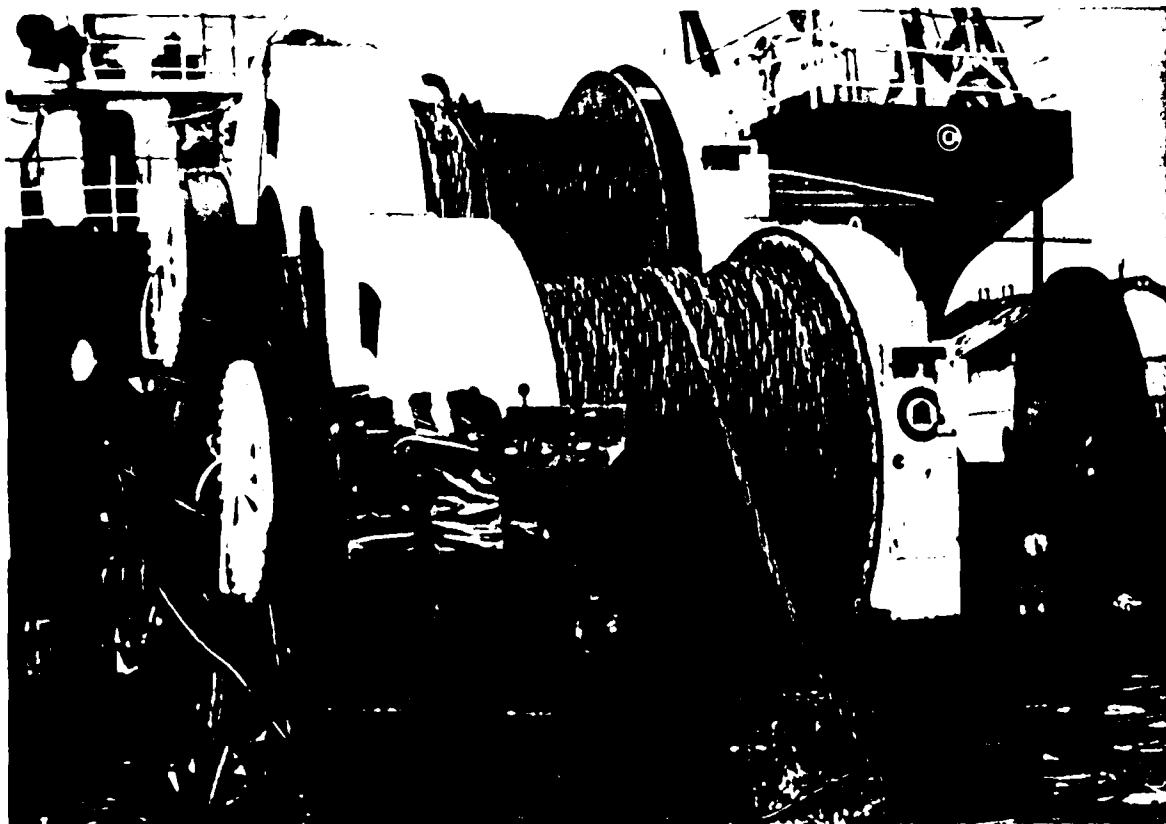
At about 0930 the CHESNAVFACENGCOM and Crowley representatives met to discuss the situation. The local Allison representatives were pulling the transmission out of the Skagit winch for determination of the extent of that problem. The winch, with the transmission removed, is shown in Figure 19. At this point it was not known when the repair might be effected.

FIGURE 19. THE SKAGIT WINCH WITH TRANSMISSION REMOVED

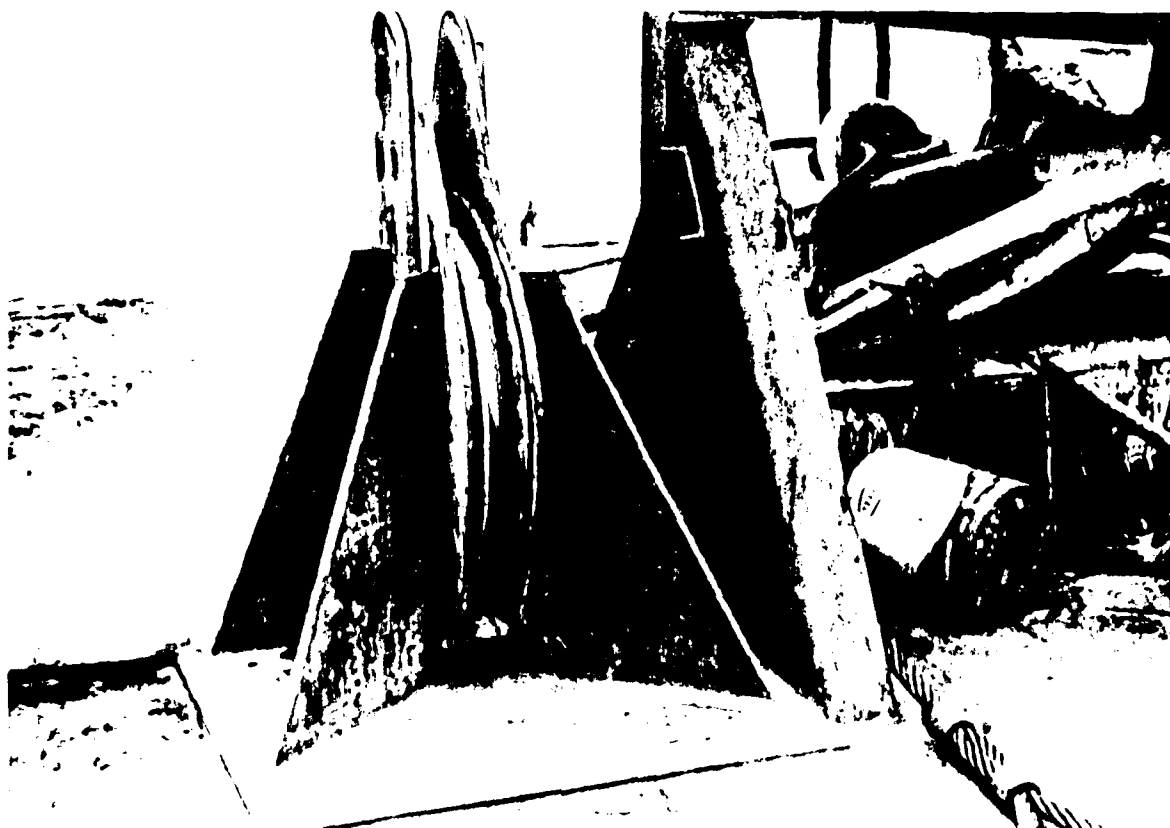
FIGURE 24. REPLACEMENT SHEAVE INSTALLED ON MANATI TRANSOM

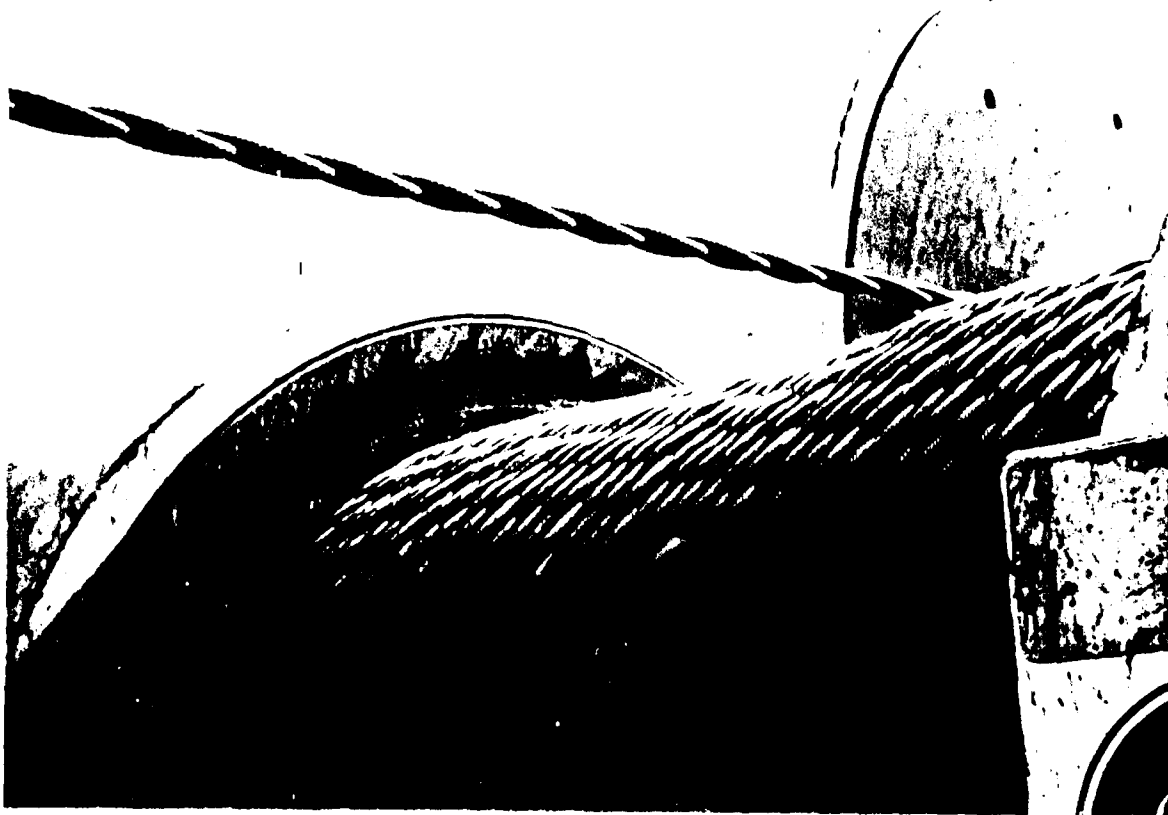
Angles were welded to the anchor flukes to permit it to skid more easily over the deck and stern. However, when tension on the line was eased, the anchor still toed into the pipe fairing over the stern and stood up on the tip of one fluke, Figure 11. The weight of the anchor, chain, and 6000 pound clump caused the 1 1/8 inch crown line to dig into the lower wraps on the winch drum.

FIGURE 39. TIGHT WRAPS OF CROWN LINE ON LOWER WINCH DRUM

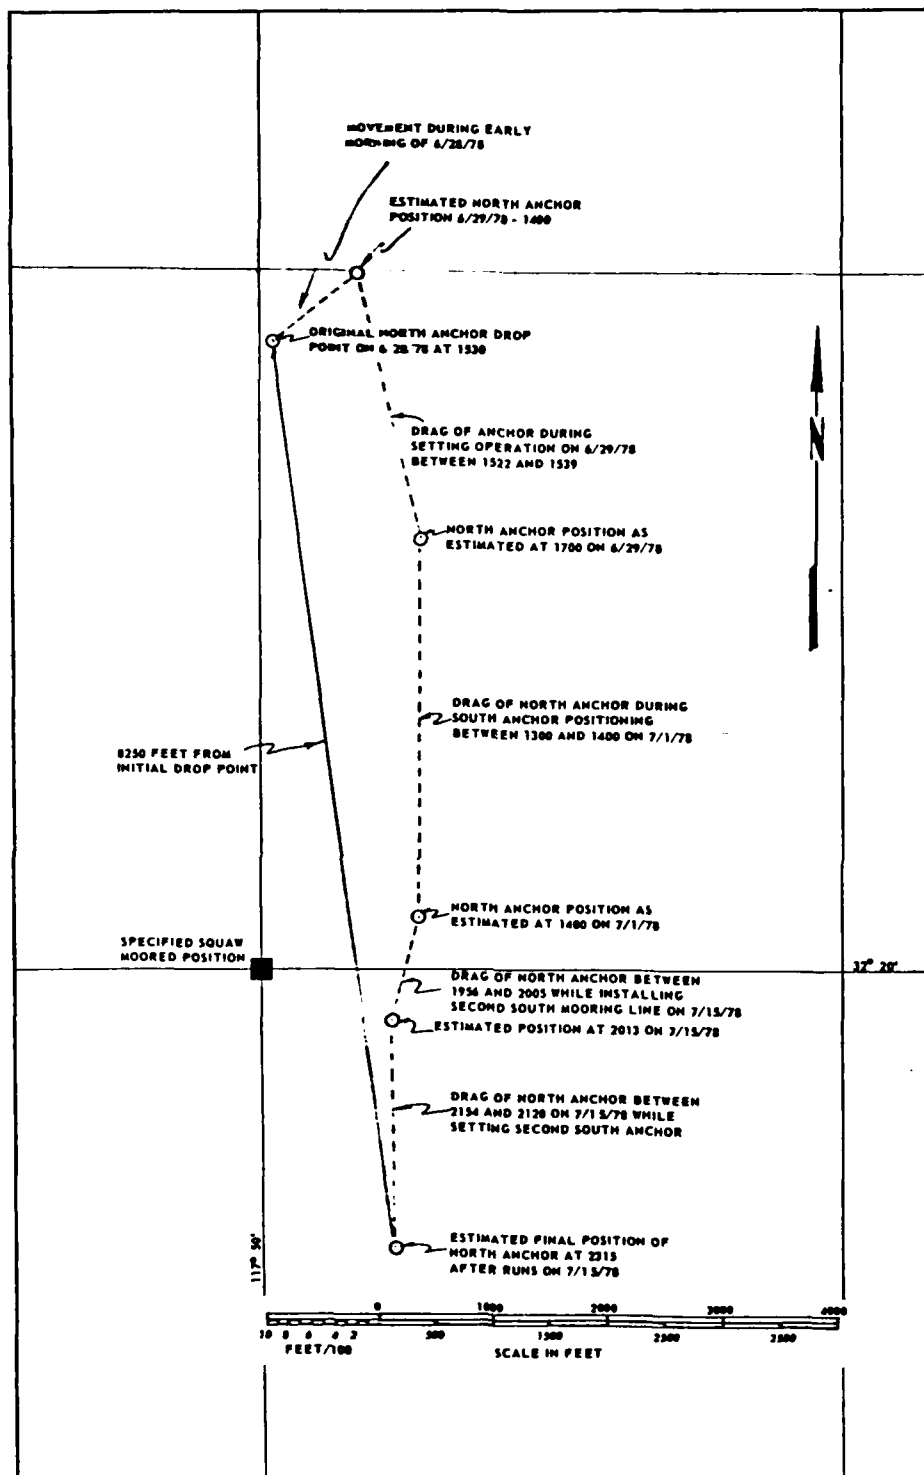
However, many of these position estimates were made on the assumption that the bow mooring line dropped in a continuous catenary down to the chain, the clump, and the anchor. It now appears that the after vertical leg crossed over the bow mooring line when it was lowered and therefore, the weight of the counterweight significantly altered the bow mooring line catenary. Later, the forward vertical leg and its lowering line also apparently crossed the bow

FIGURE 49. VARIOUS MOVEMENTS OF THE NORTH ANCHOR

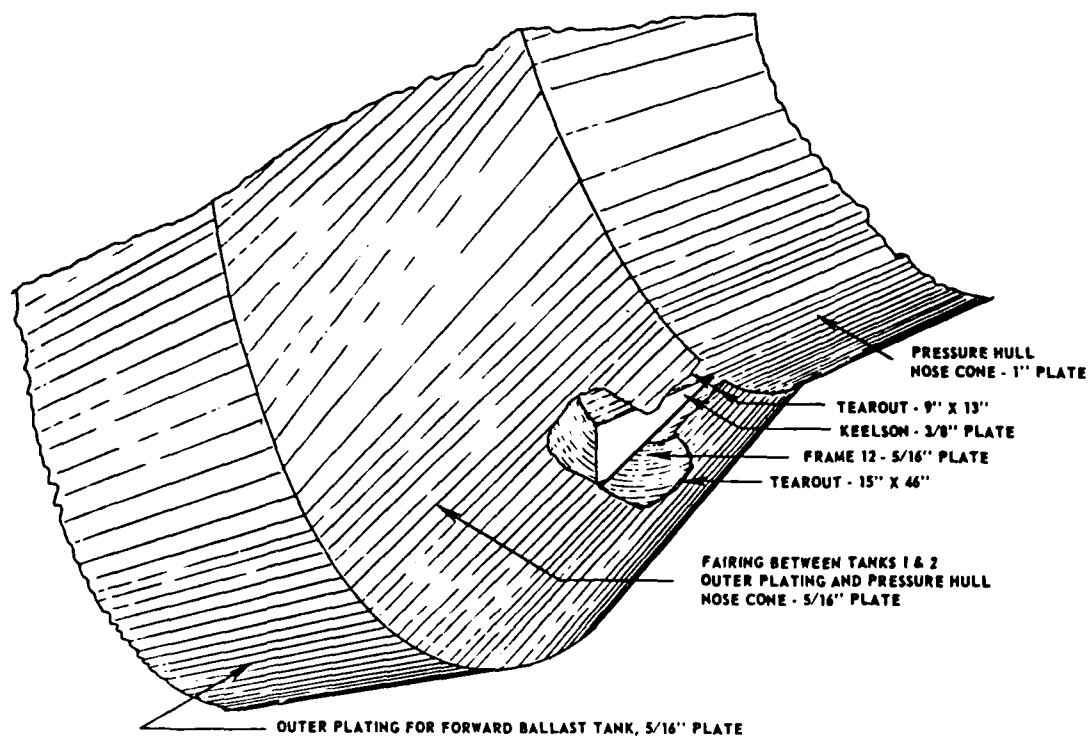
The torn area of plating, as best it can be reconstructed from the reports of divers and photographs at the scene, is illustrated in Figure 56.

LOOKING UP AT THE AREA WHERE THE FORWARD VERTICAL LEG  
PADEYE AND ITS DOUBLER PLATE WERE TORN FROM THE HULL
